# Morphological Analysis of Tiger-Stripe and Striped Pattern Deterioration on Injection Molding of Polypropylene/Rubber/Talc Blends

*K. Hirano (a, b), Y. Suetsugu (c), S. Tamura (b) and T. Kanai (a, b, c)*

## Abstract

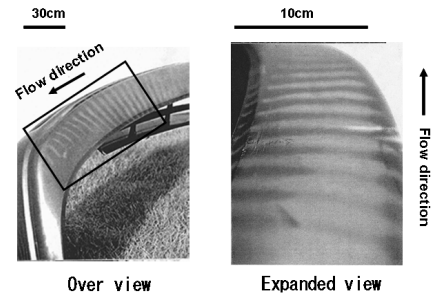
*Figure 1:* Typical tiger stripe and its deterioration.

Tiger stripe on the plate was obtained same as real parts. Previous studies have reported that the stripe consists of the alternation of glossy and cloudy parts corresponding to higher and lower degrees respectively in the orientation of dispersed rubber phases caused by a snake-like asymmetric flow during injection stage [1]. We described inconspicuous tiger stripe is controlled by polymer designs of the based PP involving narrower molecular weight distribution of homo PP portion and higher intrinsic viscosity of co-synthesised ethylene-propylene rubber portion[2]. Even though tiger stripe is inconspicuous for initial state due to these designs, in some case the stripe becomes severely conspicuous by exposing under weather for long time (*Figure 1*).

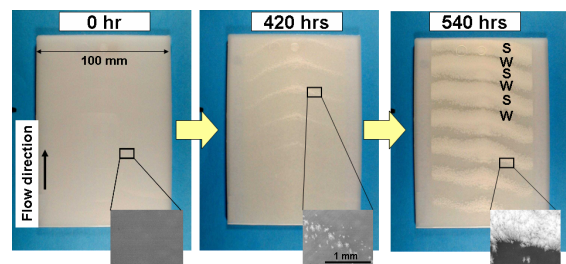
*Figure 2:* Striped deterioration with UV irradiation.

PP/rubber binary blend was examined as a model for the deterioration by irradiation with UV. Severe striped deterioration was observed with the irradiation (Figure 2) [2]. Strongly (*S*) and weakly (*W*) whitened parts corresponded to cloudy and glossy parts respectively. The chemical deterioration (C=O produced by oxidation) could not provide this striped deterioration because significant difference of C=O contents was not observed in both *S* and *W* through the depth (Figure 3).

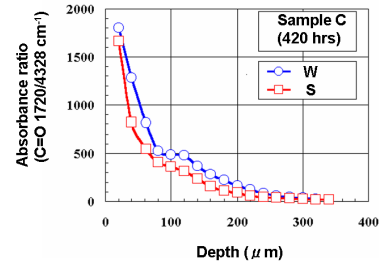
Figure 3: Depth profile of C=O caused by UV irradiation.

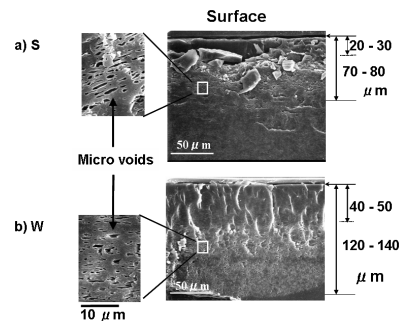
SEM photographs of the cross sections showed that numbers of micro voids occurred in c.a. 20-140 μm depth from the surface (Figure 4). Thus, it was clarified that the striped deterioration was not dependent on the chemical deterioration but on the physical one with the micro voids caused by UV. Induction depths of the voids were especially shallow in strongly whitened part (*S*) compared with weakly one (*W*). Then, it was very important where the micro voids occurred in terms of both morphology and deterioration mechanism of polymer blend. TEM photographs of the cross sections confirmed that the micro voids existed just inside the domain comprising rubber portion (Figure 5). These voids inside the domain were observed frequently in lower orientation domains under the shear zone in which the domains were highly oriented. As mentioned above, the induction depths were shallow and deep corresponding to *S* and *W* parts respectively. Consequently, a schematic model for the striped deterioration of the PP/rubber binary blend was proposed in Figure 6. Incidentally, UV irradiation up to 4000 hr could not cause any voids inside the plate with carbon black as a UV absorber. Real automotive parts probably have complicating mechanism for deterioration against weathering.

Figure 4: SEM photographs of the cross sections.

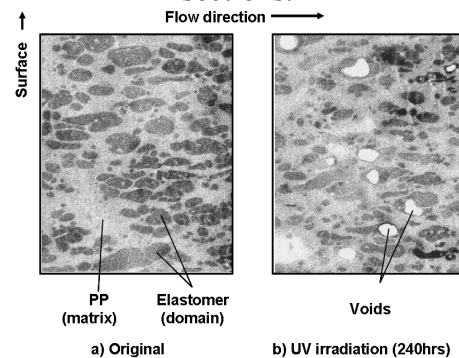
Figure 5: TEM photographs of the cross sections with/without UV irradiation

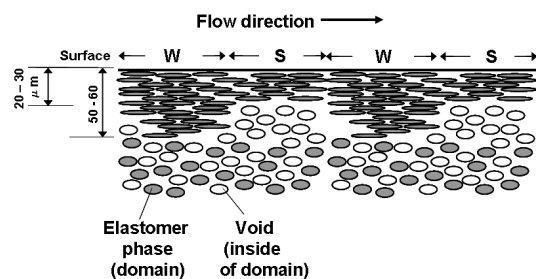
Figure 6: Schematic image for the striped deterioration of PP/rubber blend.
